# Data Line Voltage Troubleshooting and Bias Switches

Proper data voltage is essential to robust and reliable communication on the *ComfortNet™* system.

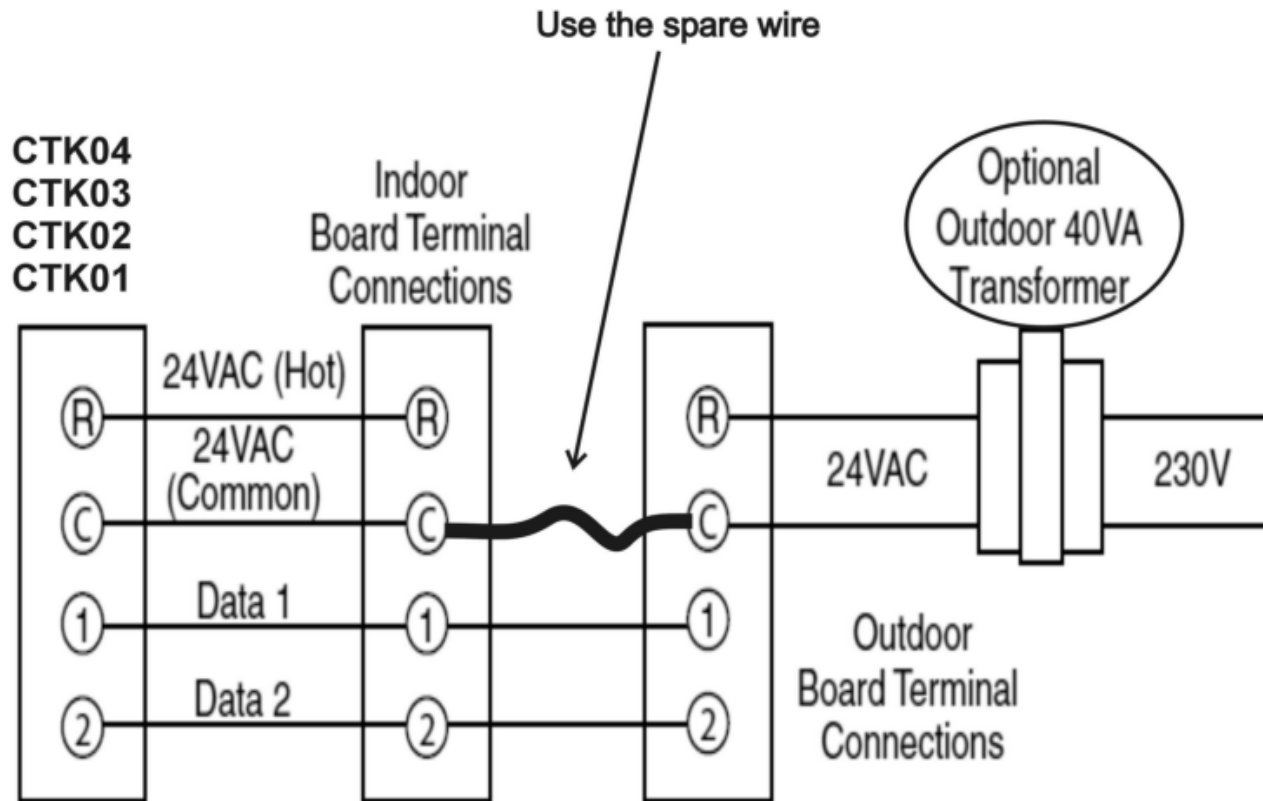
***When a transformer is installed outside*** and there are 3 wires available, use the 3rd (spare) wire to connect the two 24v commons together. *That will insure both 24v commons are at the same ground potential.*

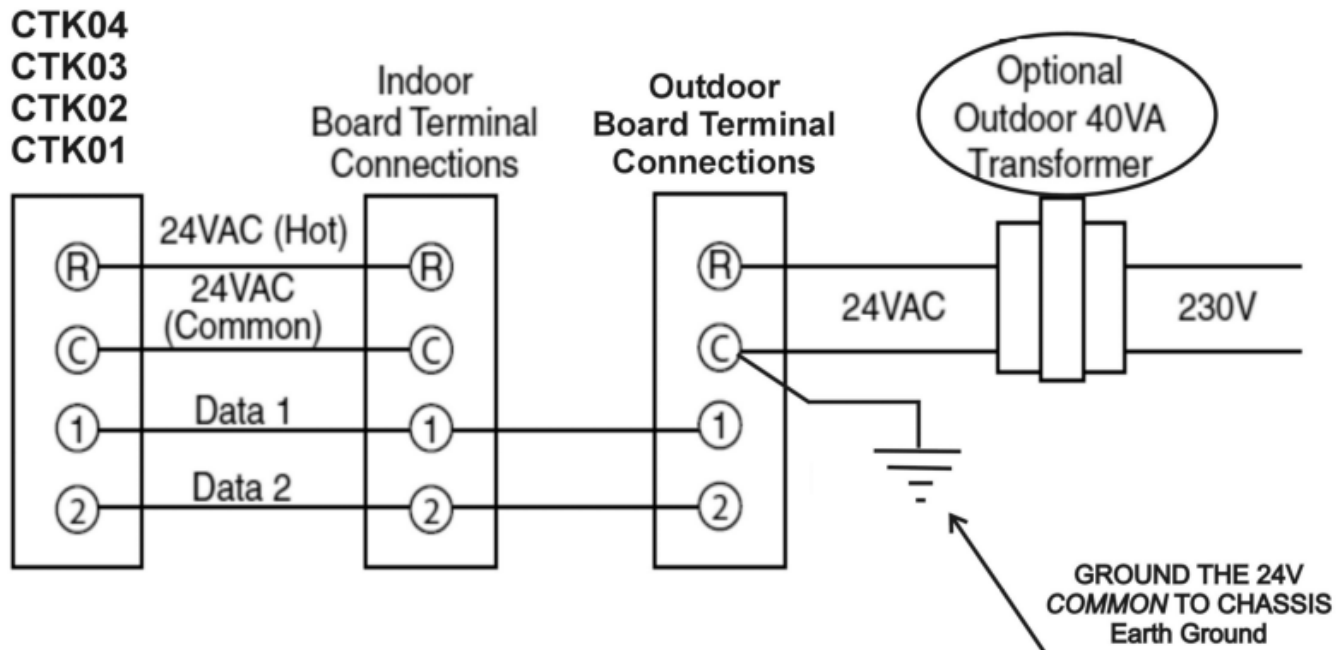
***When a transformer is installed outside*** and there are only 2 wires available, ground the “C” 24v common of the outside transformer to chassis (earth) ground! *Not as good as using a 3rd wire, but better than leaving the outdoor “C” 24v common floating.*

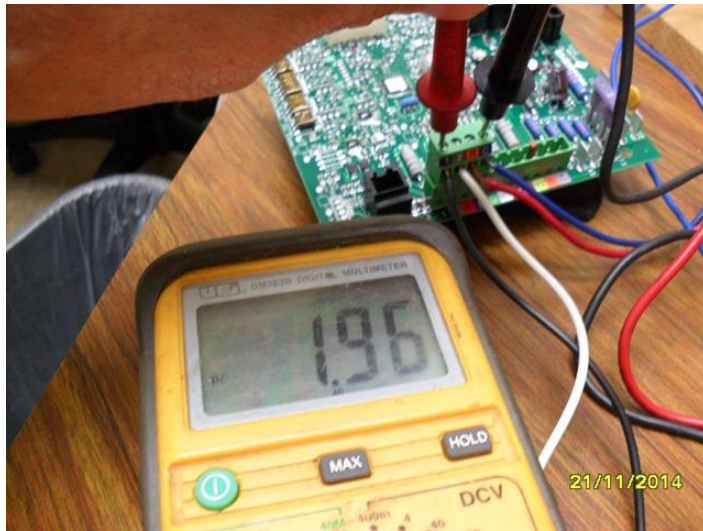
Figure 1

- Remove communicating wires from outdoor board and thermostat and check voltage at the indoor board.
- DC voltage from C to data 1 should read approximately 1.9vdc or 2.8vdc for some furnaces. (Figure 1)
- DC voltage from C to data 2 should read approximately 1.3vdc. Or 2.2vdc for some furnaces (Figure 2)
- Difference in voltage should be .6vdc.

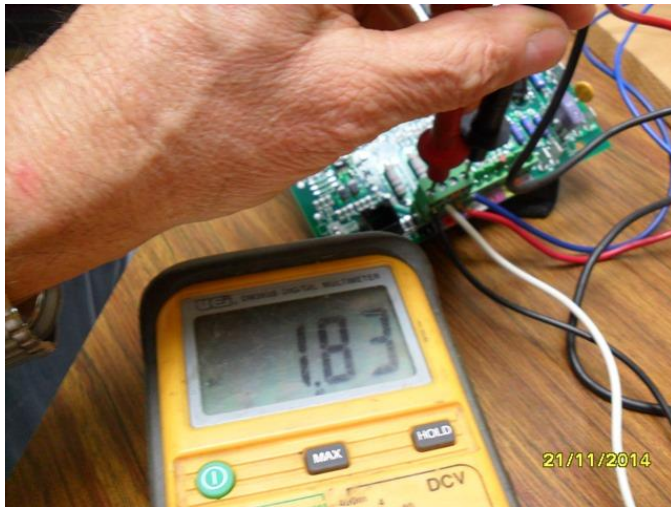
Figure 1

- DC voltage from C to data 1 now reads approximately 1.83vdc. (Figure 1)
- DC voltage from C to data 2 reads approximately 1.50vdc. (Figure 2)
- Difference in voltage is now .33vdc instead of .6vdc.
- Bias switches on outdoor board need to be changed to “off” from the factory setting of “on”.

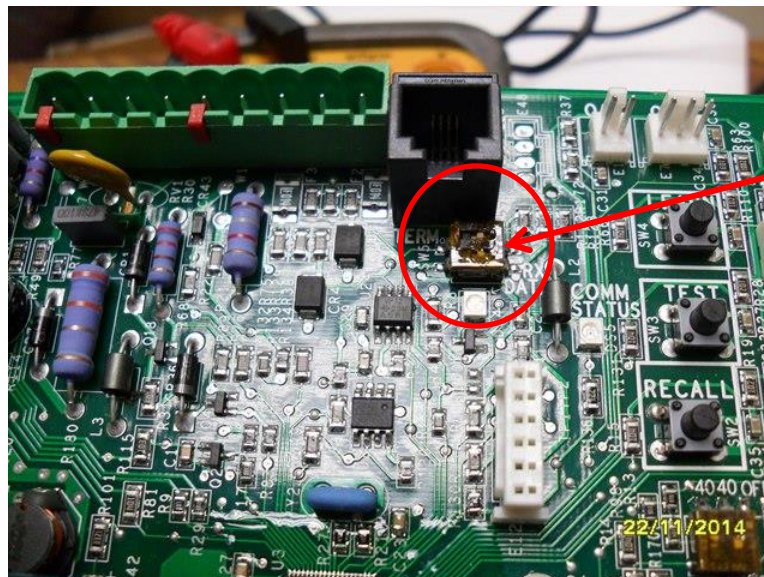
- Remove plastic film covering switches with screw driver or knife.
- Turn both Bias switches to the off position.
- Recheck DC voltage between C and 1 and C and 2.

Turn switches to OFF

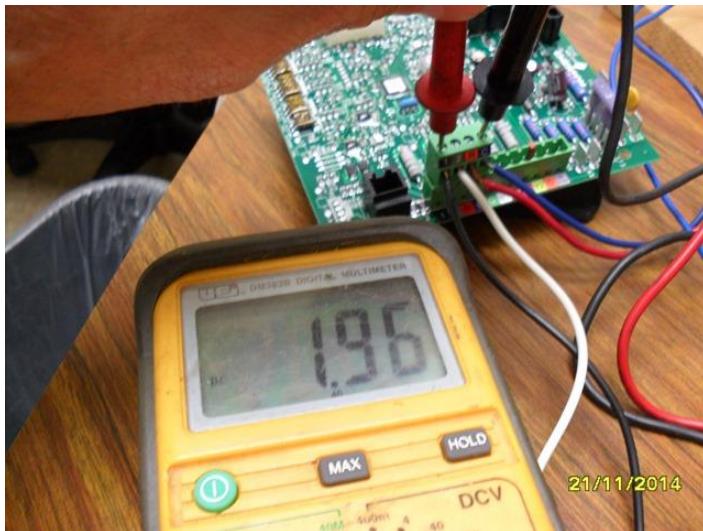
Figure 1

- Recheck DC voltage with wires from outdoor board connected.
- DC voltage from C to data 1 should read approximately 1.9vdc or 2.8vdc furnaces (Figure 1)
- DC voltage from C to data 2 should read approximately 1.3vdc or 2.2vdc furnaces (Figure 2)
- Difference in voltage should be .6vdc.
- Adjustment is complete and communication should be working.
